**Tree Solutions and Environmental
Consulting Services, Inc.**

October 8, 2019

Hawaiiana Management
Donna LaFrance
Crest at Wailuna Tree Assessment

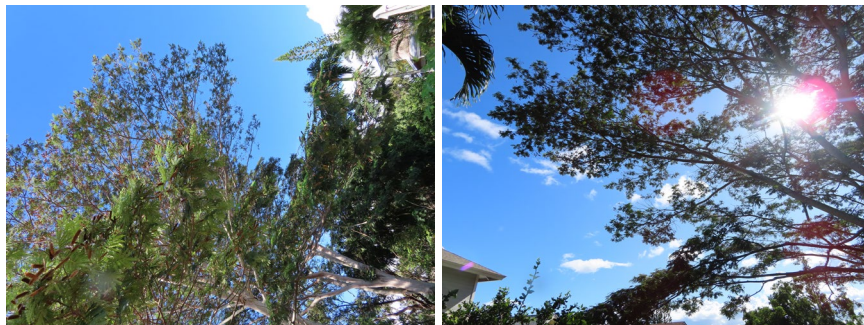
The highest risk Albizia tree #3 has potential of branch failure occurring behind Unit-118. I recommend removal or heavy directional pruning.

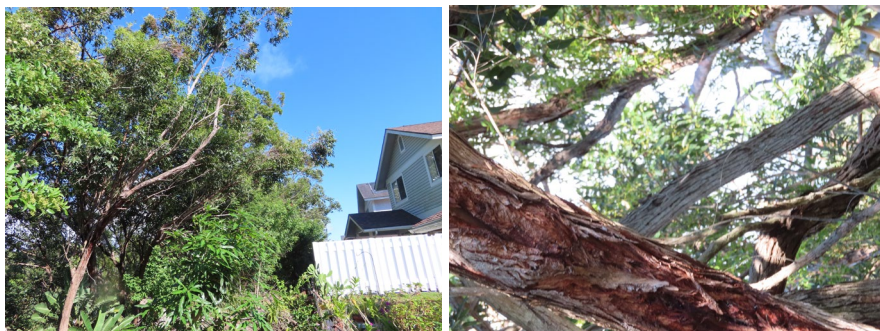
Eucalyptus #7 behind Unit-129 is decayed and leaning toward the house should be removed.

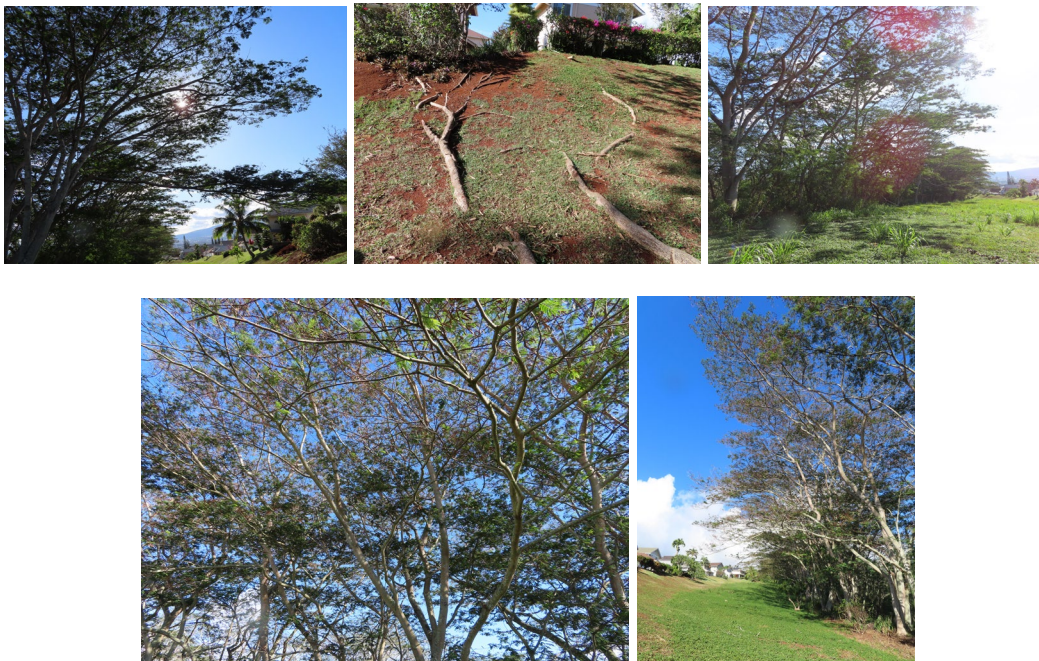
Albizia trees behind Units-13-47 are sufficient distance from Crest at Wailuna homes. The area between property fences to the edge of the Albizia tree line is well maintained creating a fire break. The area is also an area that residents can walk their dogs, exercise, and children can play. There are a lot of dead hanging and broken branches in the large Albizia trees that could fall into the open fire break. I recommend removing high-risk branches. Surface roots are extending through the entire break and growing toward the property fences and house foundations. The roots should be pruned way before the fences.
