**Tree Solutions and Environmental  
Consulting Services, Inc.**

Hawaiian Property Management  
Donna LaFrance  
Crest at Wailuna Tree Assessment

Crest at Wailuna  
Tree Risk Assessment

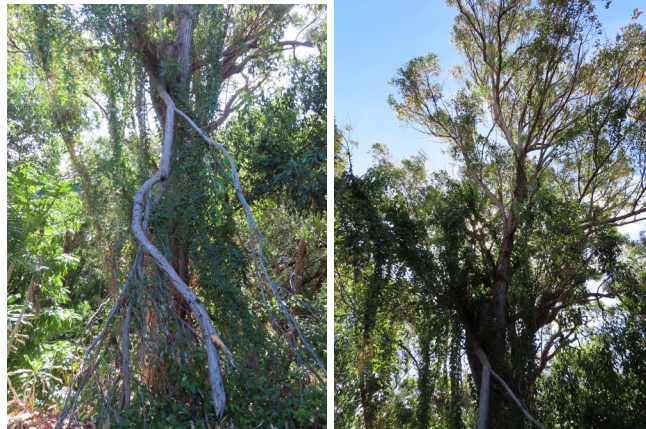
Eucalyptus tree (#14) near unit 48 has a large broken branch and should be directionally pruned.

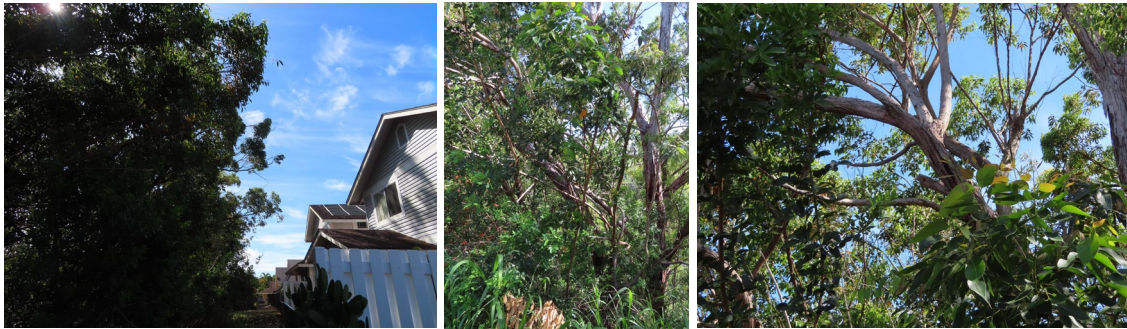
Eucalyptus cluster (#9) behind unit 129 is decayed and has several large branches encroaching Crest property. This cluster has three trees, and all are high-priority for removals.

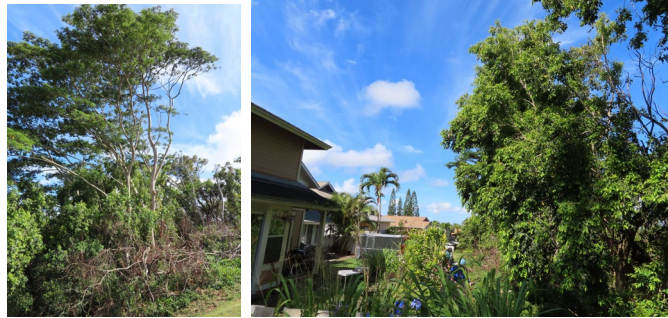
Albizia trees on the North side of the complex were directionally pruned, which reduces risk of branch failure towards the Crest at Wailuna side of the property. The remaining Albizia trees (#3, #4) pose a low risk to damaging Crest property, but should be removed in the future (medium priority).
