**Tree Solutions and Environmental  
Consulting Services, Inc.**

Hawaiian Property Management  
Donna LaFrance  
Crest at Wailuna Tree Assessment

Crest at Wailuna  
Tree Risk Assessment

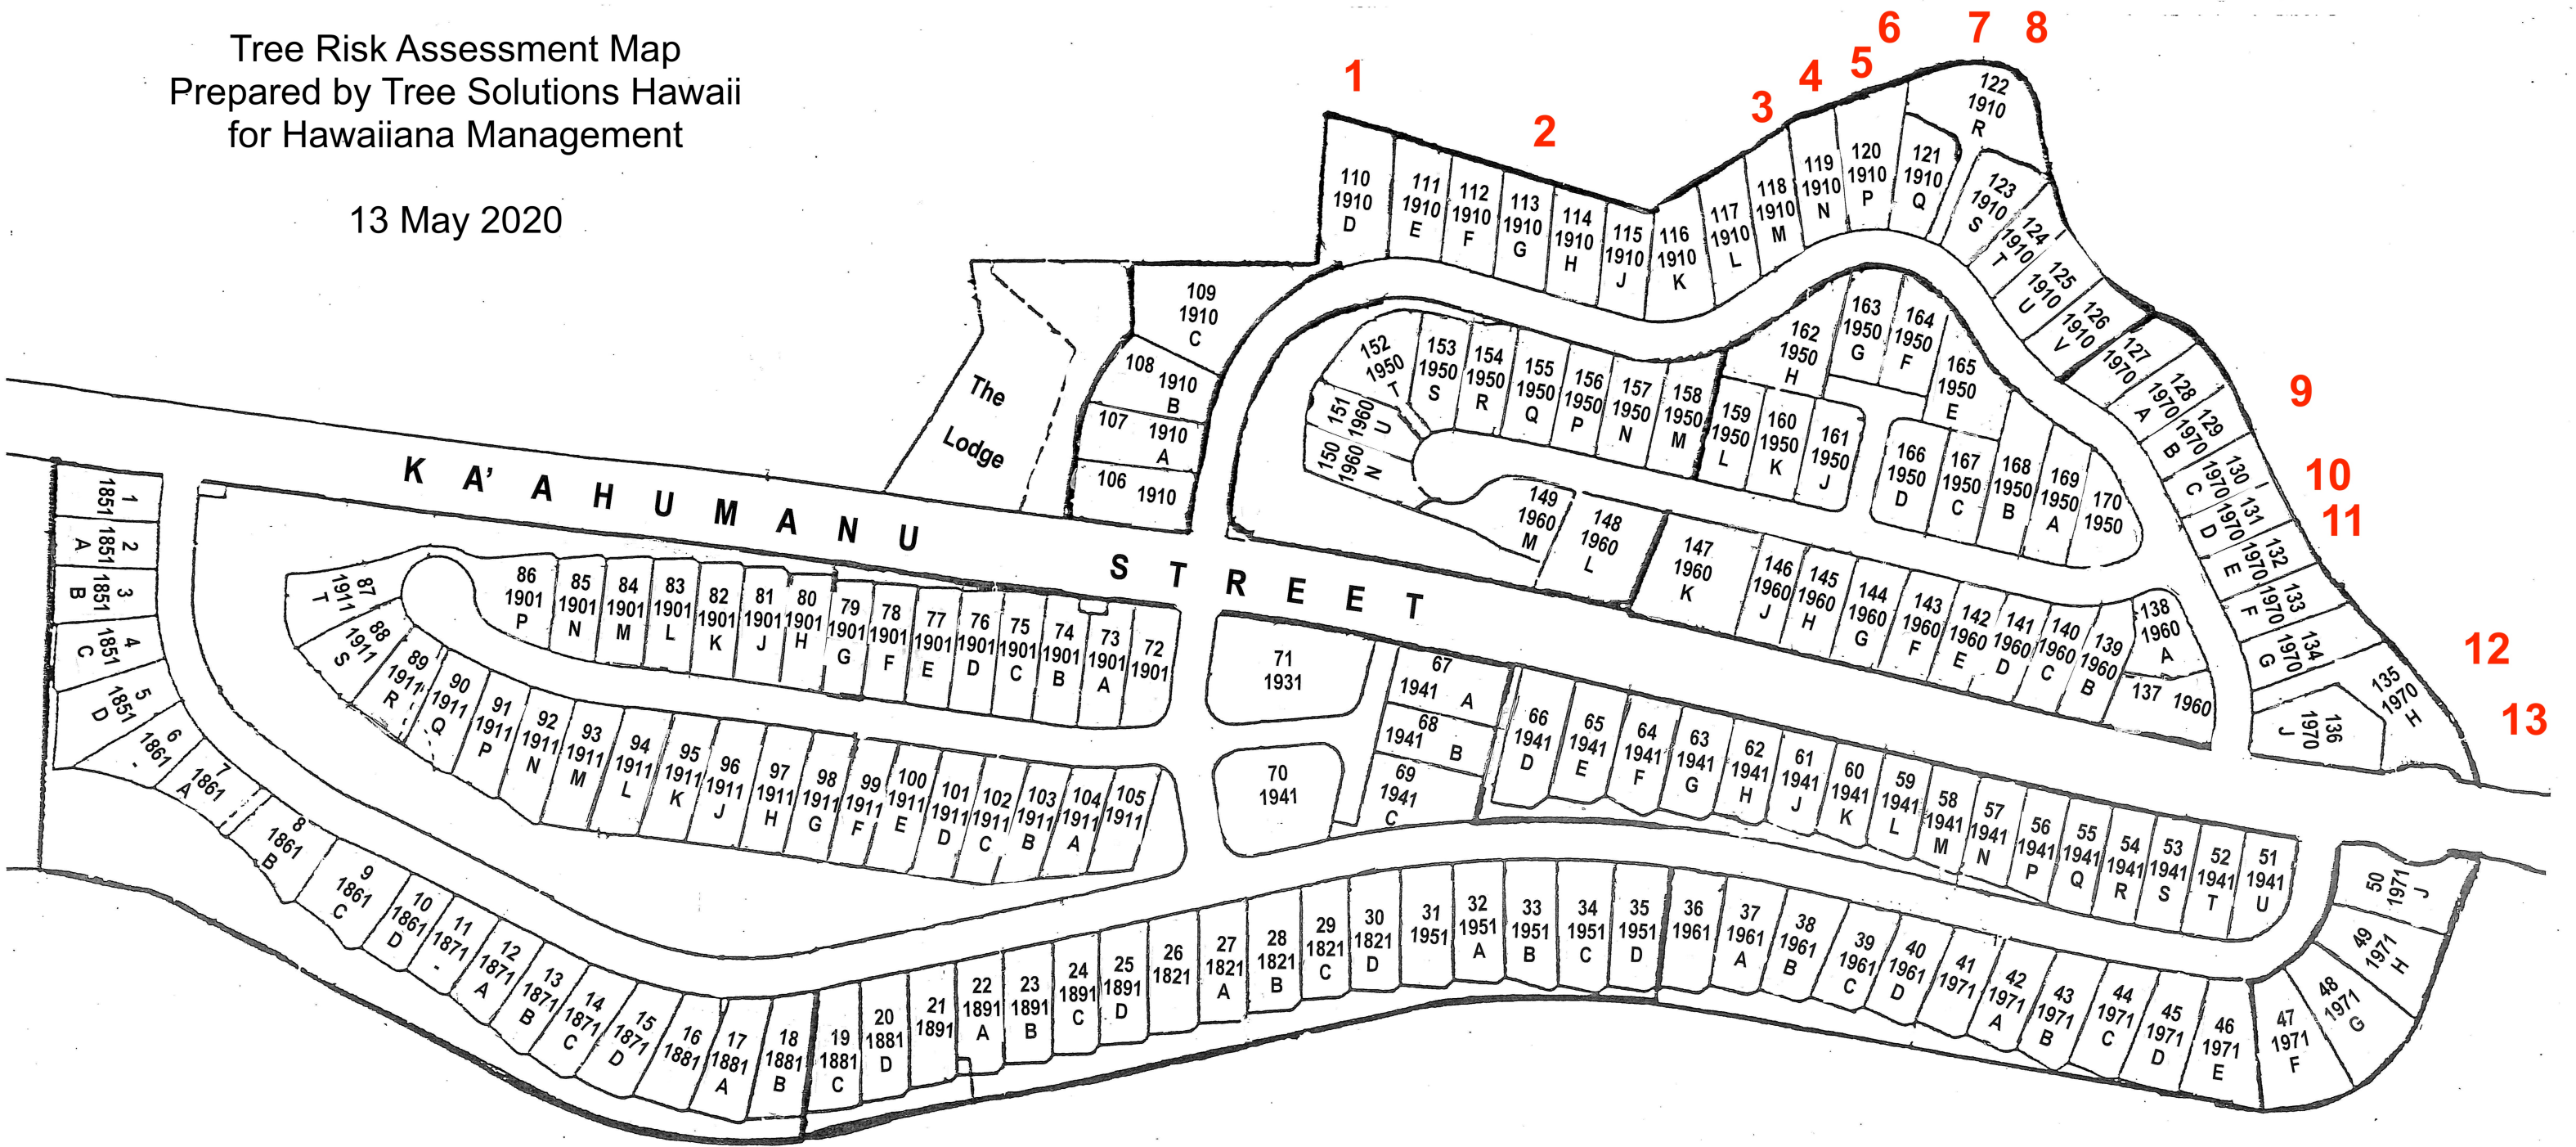
Tree Risk Assessment Map  
Prepared by Tree Solutions Hawaii  
for Hawaiiiana Management

Fifteen (15) sites were identified for pruning and removal. Locations are numbered on the site map that corresponds to the spreadsheet providing:

Eucalyptus tree (#14) near unit 48 has a large broken branch and should be directionally pruned.

Eucalyptus cluster (#9) behind unit 129 is decayed and has several large branches encroaching Crest property. This cluster has three trees, and all are high-priority for removals.

Albizia trees on the North side of the complex were directionally pruned, which reduces risk of branch failure towards the Crest at Wailuna side of the property. The remaining Albizia trees (#3, #4) pose a low risk to damaging Crest property, but should be removed in the future (medium priority).

A proactive pruning and removal program are recommended to reduce potential failures and reduce maintenance costs.
